Soft rot Determines Service
life of L-Joints with low
Borate Loading

**P.I. Morris, J. Wang and J.K.
Ingram**

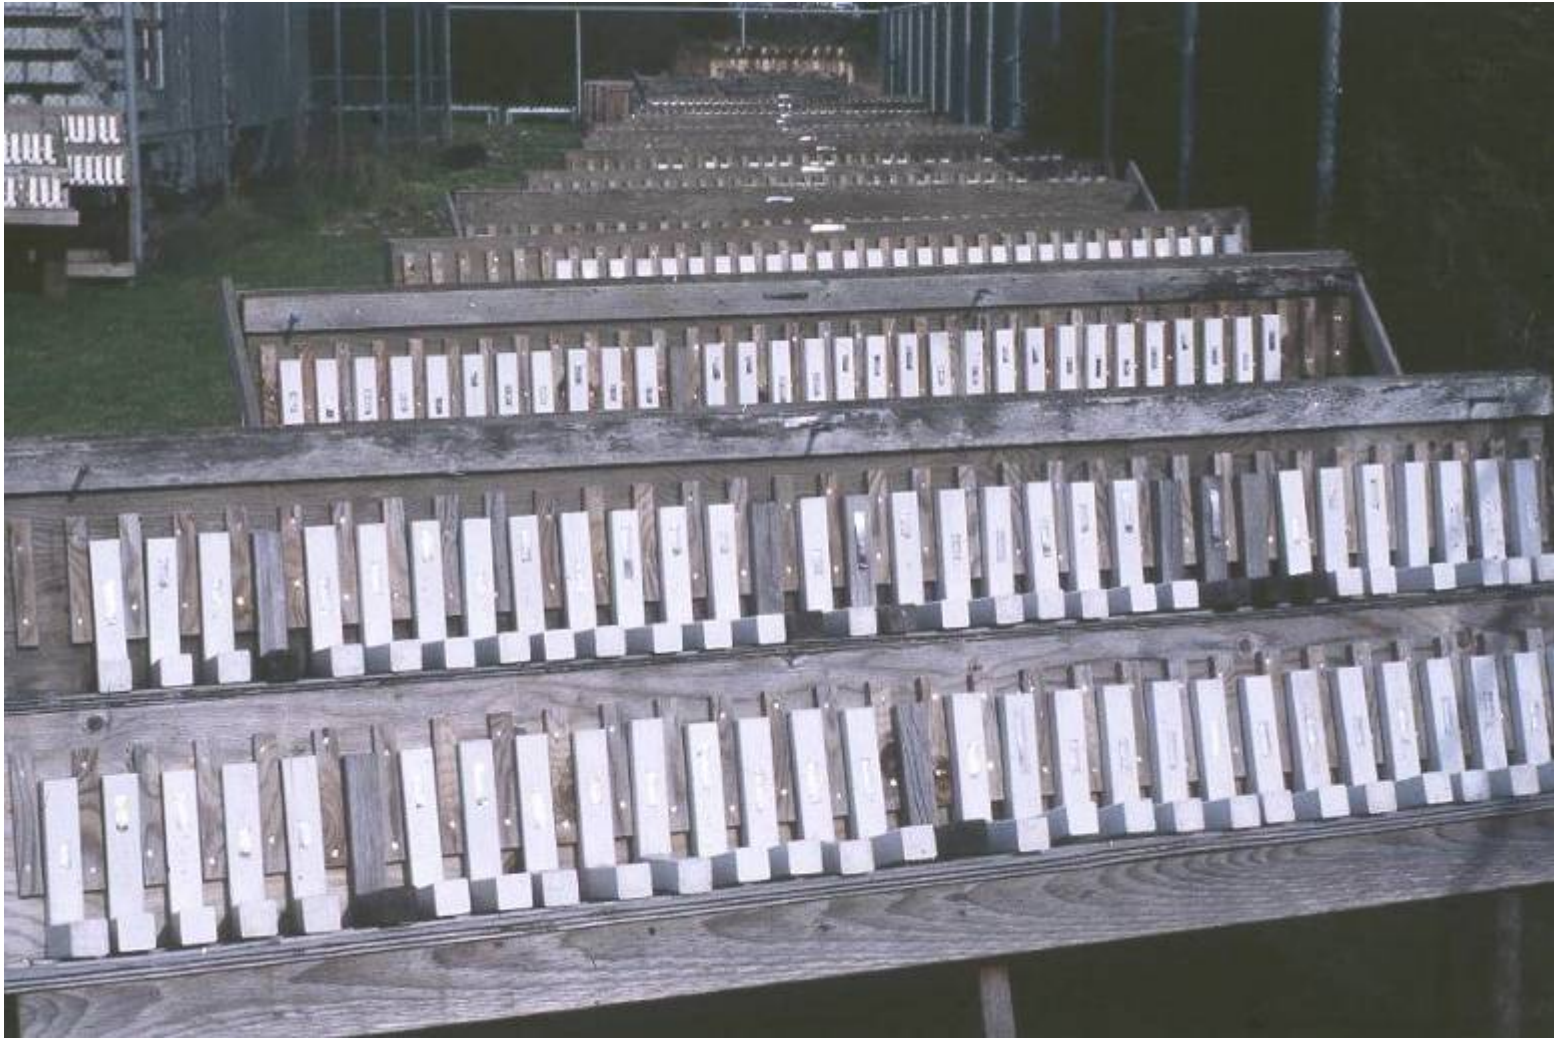
L-Joint Test Site

- L-joints cut from diffusion treated Hem-fir
- Analysed at 0.2% BAE
- Painted with standard alkyd paint
- Exposed in Vancouver 10 years
- Sheffer index = 45 (moderate decay hazard)
- Primary challenge - *Gleophyllum* species

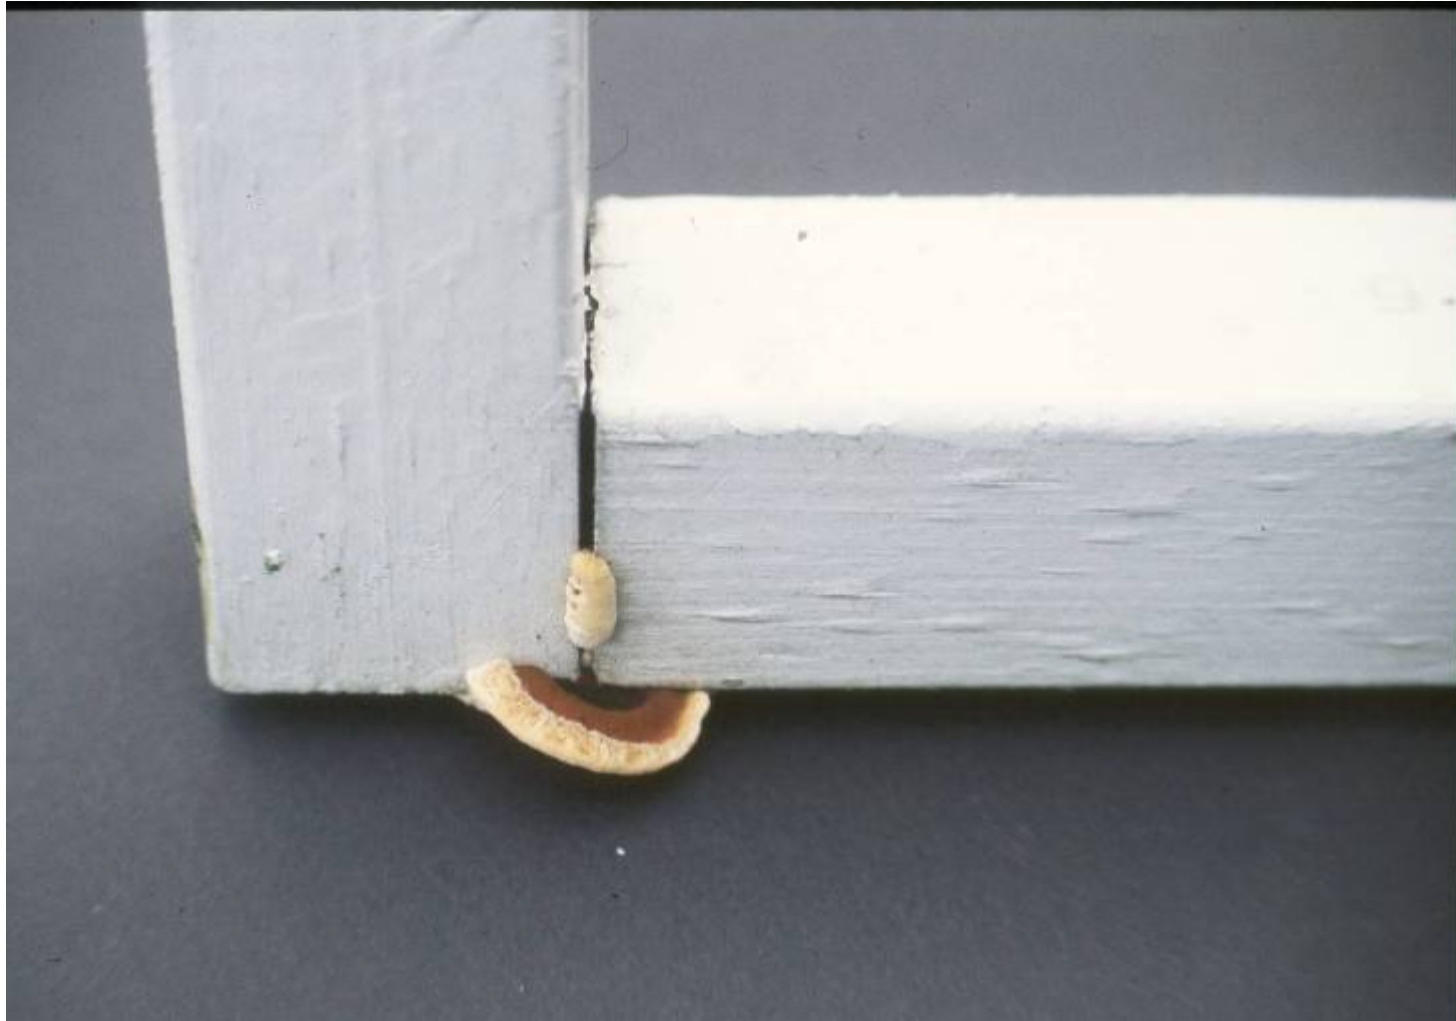
Gleophyllum sepiarium

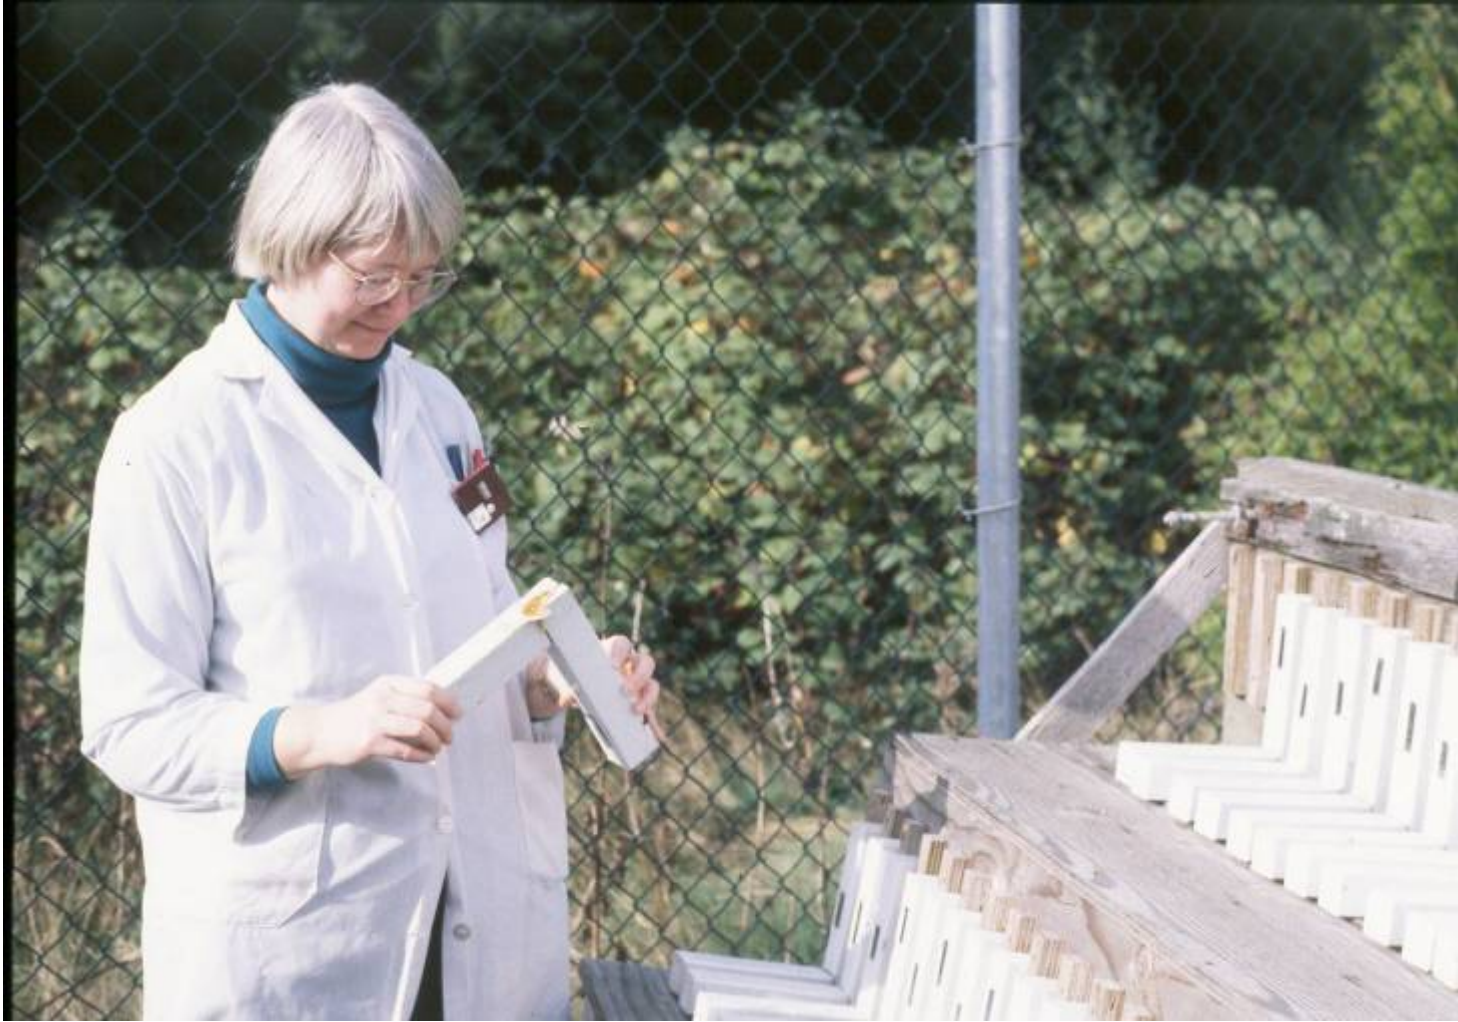
L-Joint Inspection

Inspection using Old AWPA Rating Scheme

- 10 Sound
- 9 Signs of slight surface decay
- 7 Small zones of obvious decay
- 4 Extensive decay
- 0 Rejected due to decay

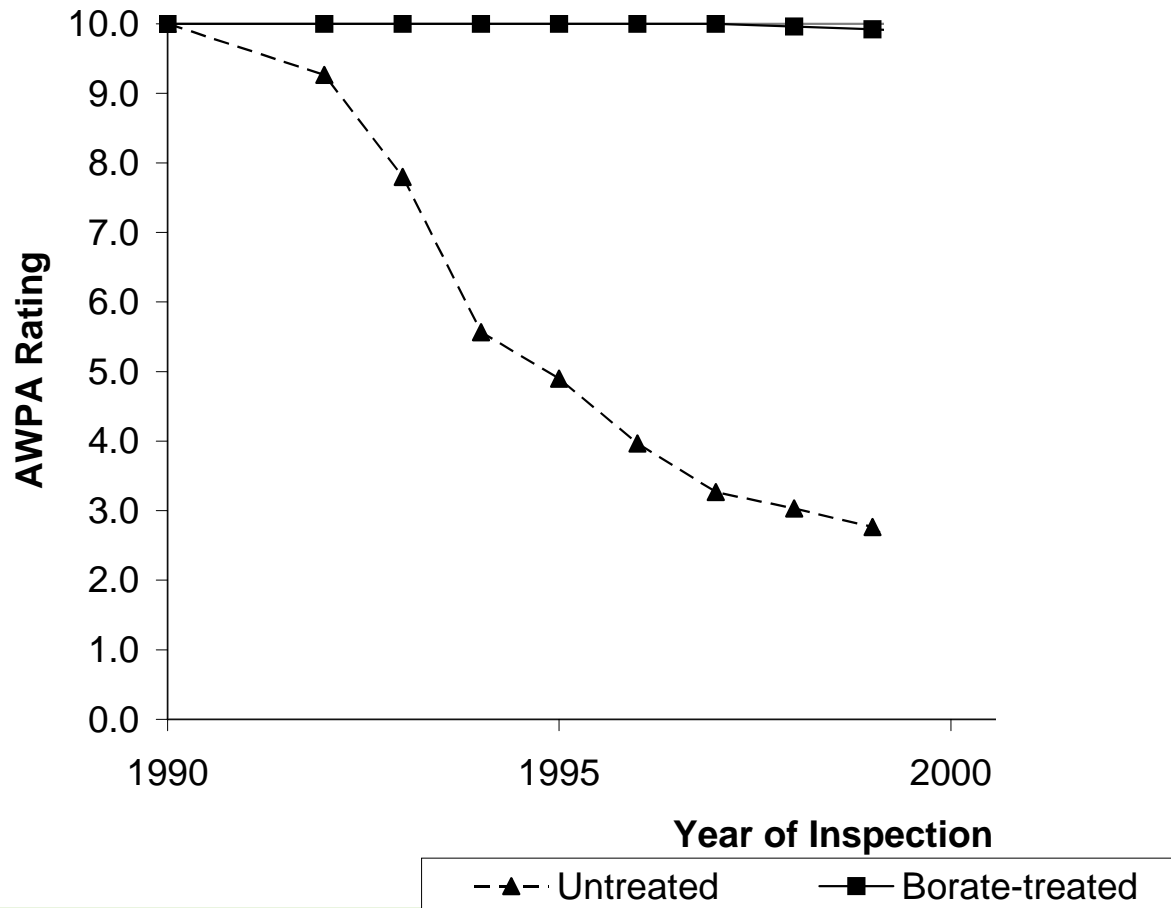
Performance Against Decay to 2000

5 years

- No detectable borate in joint zones

9 years

- Untreated: 13% sound, 21% decay, 66% failed
- Treated: 91% sound, 8% rated 9, 0% failed

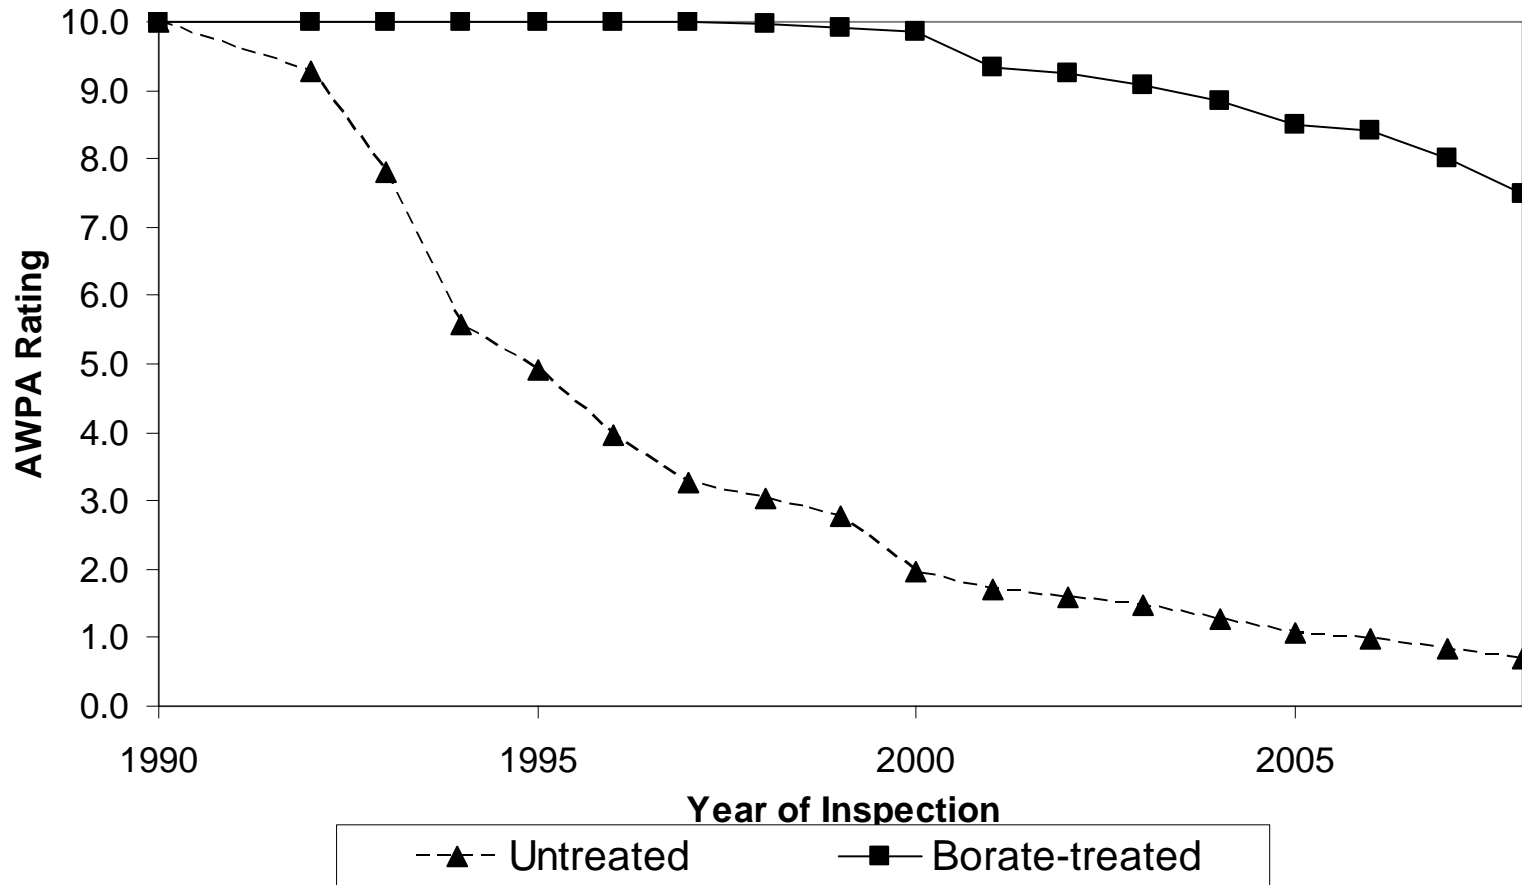
Performance Against Decay to 2008 (May 18th)

Status of Borate Treated Material at Year 17

- Rate of decay very slow
- Pick test suggested soft rot
- Samples microscopically examined

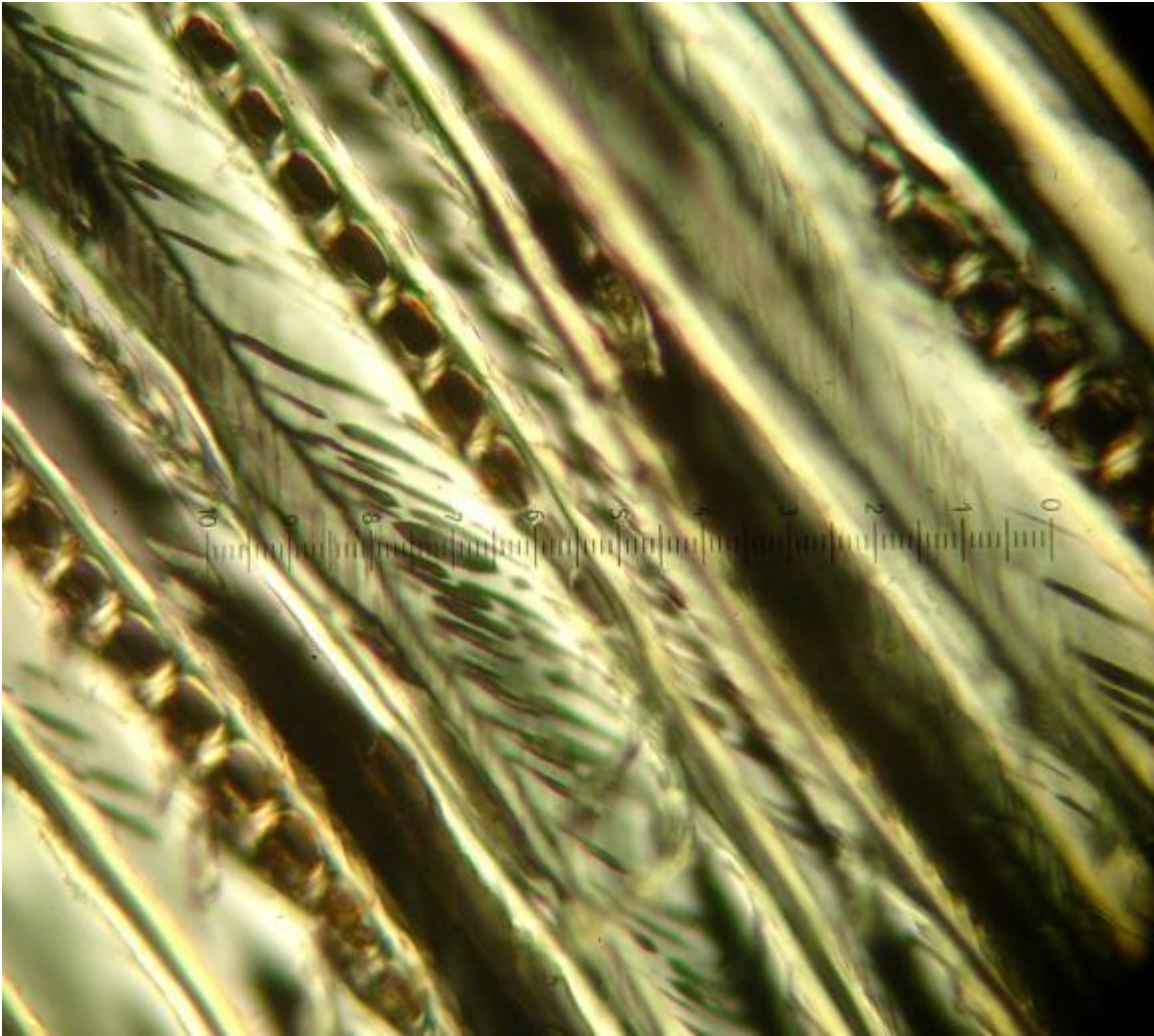
Soft Rot in L-joints after 17 Years

Decay Types Noted at 17 years

Basidiomycete	Soft rot
Untreated	18*	3
Borate Treated	2	21

* Failed due to decay visually assessed as brown-rot or white rot
May also have had undetected soft rot
